Shoreline Movement Study, Point Peron Rockingham

Department of Transport
New Coastal Assets Directorate
Coastal Infrastructure Business Unit
Marine House, 1 Essex Street, Fremantle WA
PO Box 402 Fremantle, Western Australia 6959

Review	Issue Description	Author	Reviewed By	Date
A	Draft	SB		May 09
0	Final Draft	SB	KI, CB, LR, FL	16 June 09
1	Final	SB	DEC	16 Dec 09

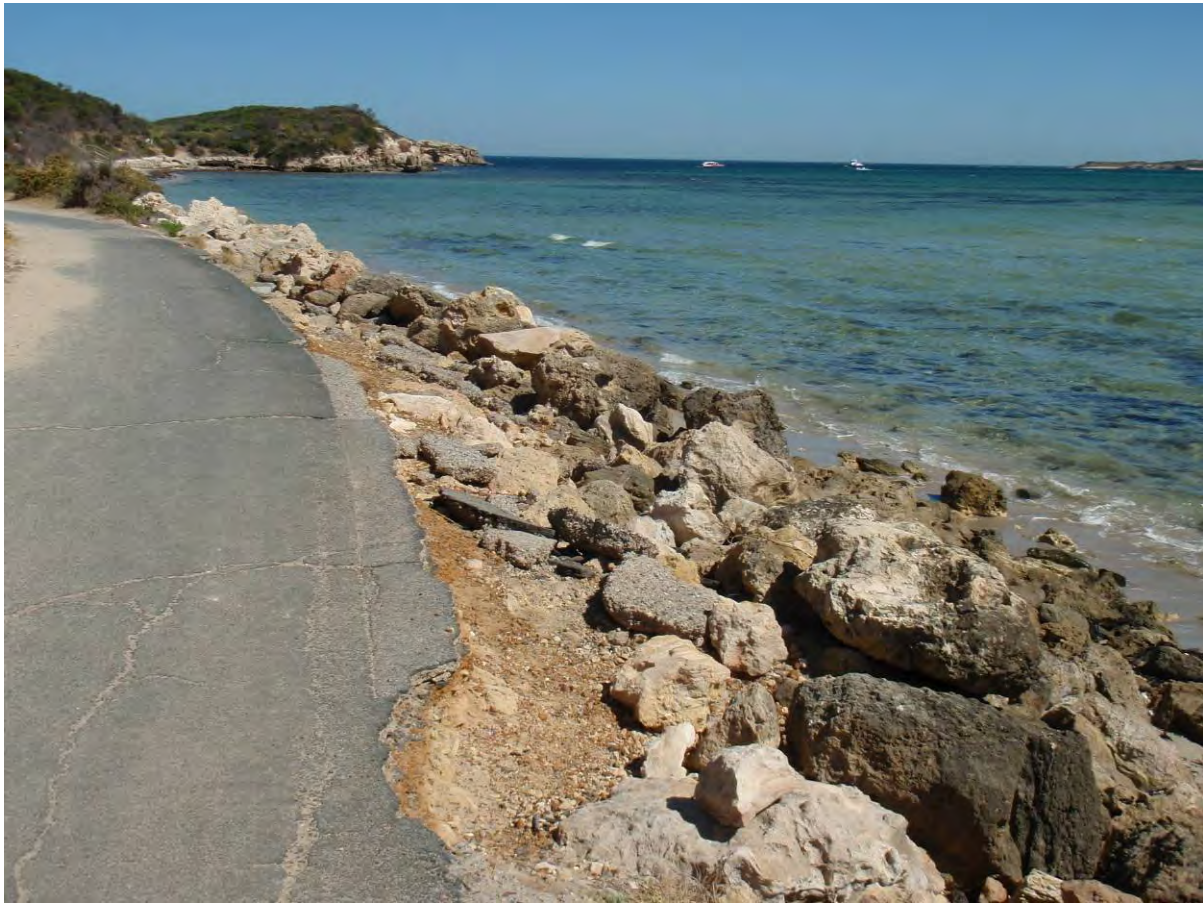
A seawall was constructed in the late 1980's along the coast adjacent to the dual-use path (Figure 2). Its purpose was to provide protection to the path from wave action. It is likely that the seawall was not formally designed and limestone rocks were simply deposited along the path's edge. The seawall is

currently in poor condition with large gaps and there are cracks and breakages along the path's edge (Figure 3).

Figure 3: The seawall alongside the dual-use path (27/2/2009)

The seawall that protects the dual-use path is currently in poor condition and if it is not maintained or upgraded, then it will eventually collapse due to erosion of the beach surrounding its structure.

It is likely the seawall was not a formally designed structure, instead rocks were simply deposited along the edge of the path to help protect it. The seawall's current condition is poor and therefore an engineered seawall would have a greater influence in protecting the dual-use path from further erosion. Reconstruction of the seawall will require new rock and use of existing rock to provide sufficient protection along the path. It is likely that a small section of beach on the eastern side of the seawall will experience accelerated erosion caused by waves reflecting off the seawall. Depending on the width of the seawall, sand might initially accumulate on the western side of the seawall and may exaggerate erosion on the other side. Ongoing maintenance of the structure will be required. The seawall will need to be redesigned by a suitably qualified coastal engineer.

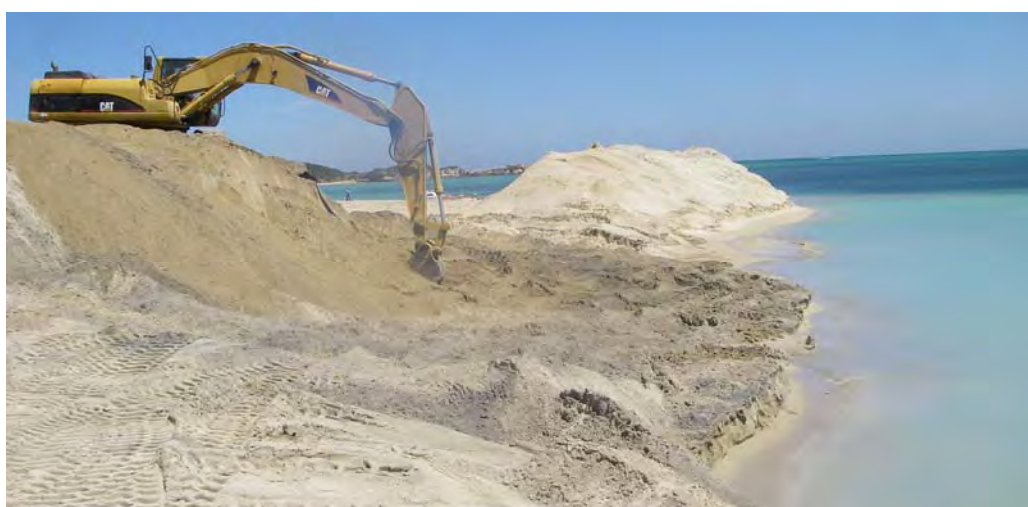
Sand has been excavated from the sand trap since the early 1990's (Figure 4). Removal of sand did not originally occur on an annual basis. Over the last 8 years, however the sand trap has been excavated annually. This has normally been conducted in two separate extractions typically during April to May and September to October. Between 2006 and 2008, approximately 10,000 cubic metres (m³) have been removed each year. The removed sand is stockpiled near the site and then trucked to Rockingham, Kwinana and Warnbro Sound beaches, depending on renourishment requirements. Actual volumes of sand have not been recorded, however Table 2 shows the approximate sand volumes removed since 2000.

Figure 4: Sand trap at Point Peron during excavation works in November, 2007

Sand trap excavation works that began during the early 1990's involved removal of sand from the sand trap which was built in 1990. These works are essential in preventing sedimentation of the boat launching facility. It is unlikely these works have been the cause of erosion to the west.

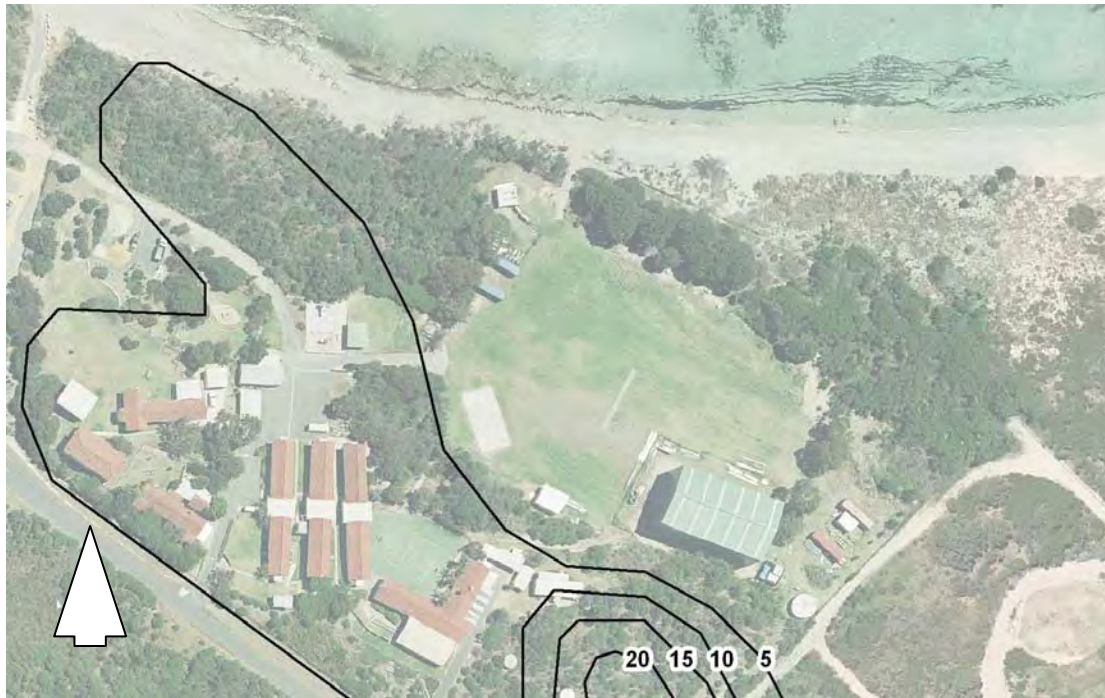
The entire camp school is below 5 mAHD (Figure 12). A brief field survey was conducted of the oval in May 2009, indicating that the approximate average height of the oval is 1.3 mAHD. The implication of these results is that during a reasonably energetic storm (likely to occur approximately once per year) water levels will reach 0.9 mAHD (estimated storm mean water level) which are likely to erode the dune buffer, but unlikely to inundate the oval. The runup height of individual waves during a storm event (2.9 mAHD), however, is likely to cause inundation of the seaward edge of the oval and further accelerate erosion.

Figure 12: Contours around Point Peron camp school and oval (elevation in metres above AHD) Source: DoT (Spatial Information section)

Over the last decade the study area has experienced on average, 2.5 metres of erosion per year. The oval is currently approximately 25 metres away from the vegetation line and is less than five metres above AHD (Figure 12). If the recent erosion rate continues, then the oval could be subject to erosion in 10 years. During energetic storm events elevated water levels may cause the oval to inundate sooner. The mean storm water level is estimated to be approximately 0.9 mAHD. Under these conditions, significant erosion of the dune buffer is expected. The runup height of individual waves during a storm event (2.9 mAHD) is likely to cause inundation of the seaward edge of the oval and further accelerate erosion.

Erosion along the western side of the study area is likely to continue as the shoreline is still adjusting to the Causeway. A controlled retreat along the western side would allow erosion to continue until the shoreline reaches a stable form. This process of shoreline stability will most likely involve the partial loss of the dual-use path and dune in front of the camp school. Therefore the dual-use path would need to be relocated, however due to the nature of the terrain, large earthworks and vegetation removal will be required. Closure of the dual-use path will prevent access to a popular tourist and fire access area. Due to recent years of seawater inundation, the oval's size may need to be reduced to increase its distance from the beach.

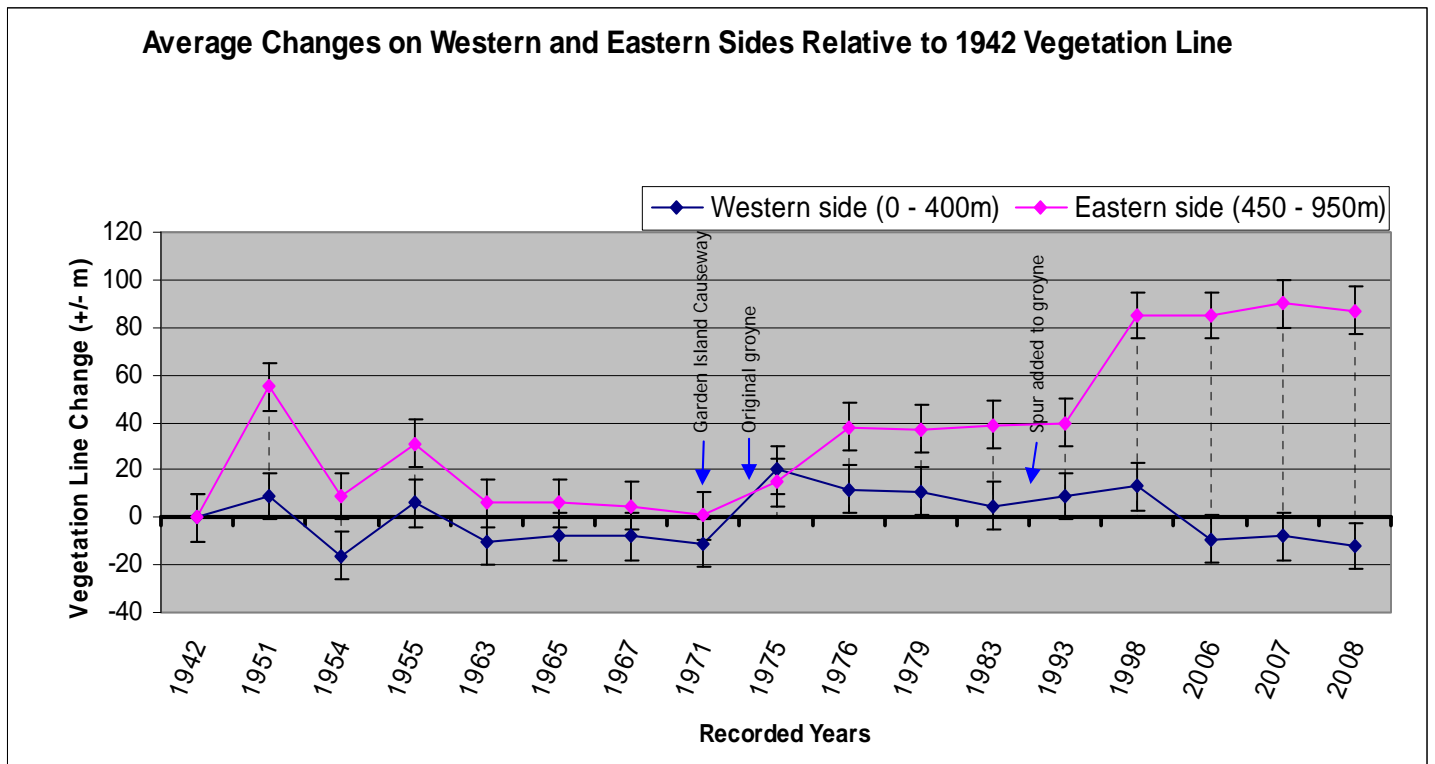
The study area was divided into two sections, a western (chainage 0 - 400m) and an eastern side (chainage 450 - 950m) due to the different changes that have occurred in each over the 66 year period. Figure 20 displays a graph of the average changes for both sides. Average changes for each year were calculated by averaging the distance between the 1942 vegetation line and the year of interest for each of the 50 m cross-section lines. The Garden Island Causeway (1971-1973) appears to have had an impact on both the western (0-400 m) and eastern (450-950 m) sections of the shoreline. Prior to the Causeway, 4 years recorded between 1963 and 1971 showed signs of a dynamically stable shoreline on both sides (eastern and western). Both sides began to accrete after the causeway was built. The 4 year period between 1971 and 1975 saw an accumulation of approximately 31 and 14 metres for the western and eastern locations respectively. From 1975 onwards, the western side has been generally eroding whilst the eastern side has been steadily accumulating, with 45 m accretion from 1993 to 1998. Between 1998 and 2008, the beach in the western section (0 - 400 m) has retreated approximately 25 metres.

Figure 20: Average changes on each side of the study area (western and eastern) during the 66 year period (Estimated error is ± 10 m)

The Causeway has impacted greatly on the sediment transport throughout Cockburn Sound. The impacts of the Causeway can be clearly seen in Figure 20 (average changes). The Causeway was constructed between 1971 and 1973 and during this time the shoreline in the western half of the study area began to change.

Vegetation lines for the 17 recorded years were plotted against the 1942 vegetation line. From this information, years of accretion and erosion can be tracked. Between 1971 and 1975, there was found to be an accretion of 31 metres on the western side and 14 metres on the eastern side of the study area. The recorded years from 1975 onwards show that the eastern section has been steadily accreting, especially between 1993 and 1998 (45 m). The western side has generally been eroding since 1975 onwards with the most erosion occurring between 1998 and 2008 (25 m).

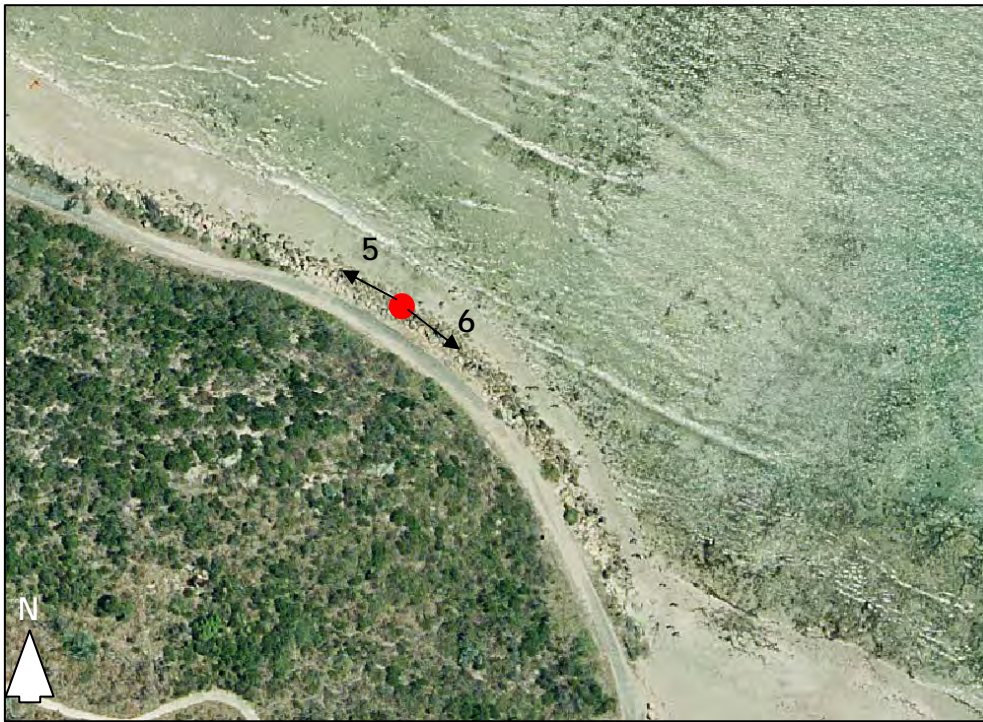
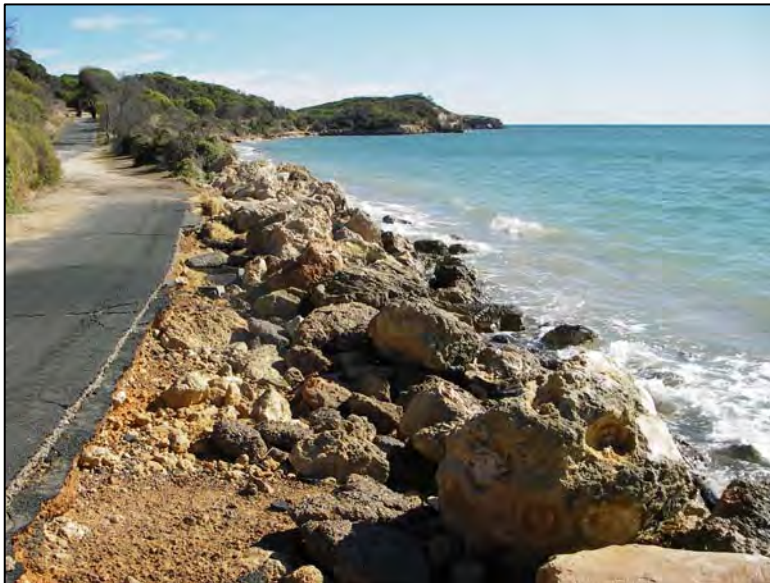
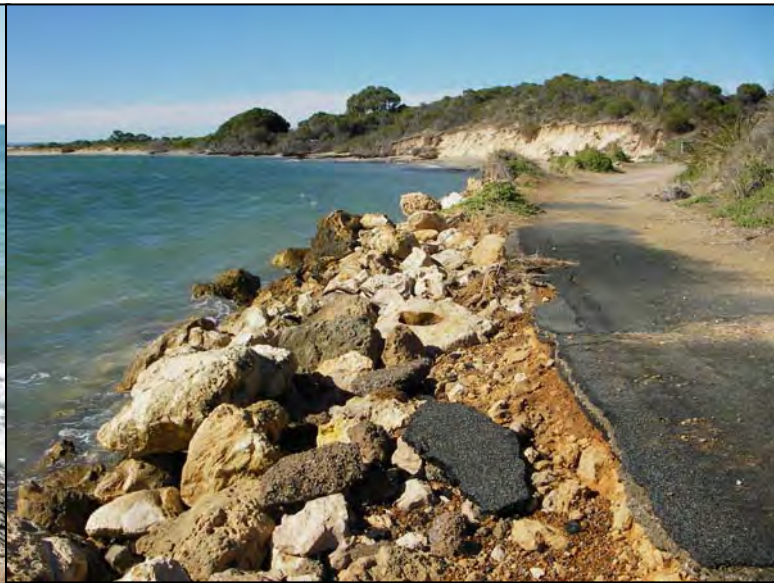
These photographs were captured near the bend in the dual-use path and seawall. Photograph 5 is taken facing back towards the west. Photograph 6 is taken facing towards the dune in front of the camp school. These photographs display the seawall and path's condition.
